ASSESSING SUBSTATION MEASUREMENT

# LCN FUND TIER 1 CLOSE DOWN REPORT LV CURRENT SENSOR TECHNOLOGY EVALUATION

**AUGUST 2013**

OMER KHAN UK POWER NETWORKS

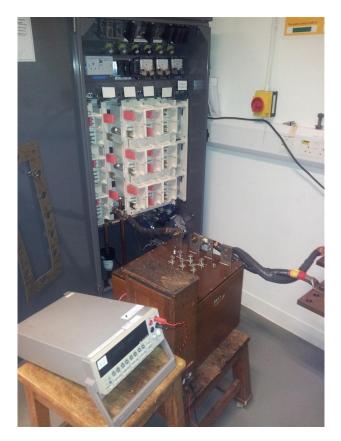
A selection of laboratory tests were undertaken so that a comparative study could be carried out between the different monitoring solutions. For the tests, a LV sensor was fitted to a vertical conductor representative of an individual phase core of an LV cable as found in a typical secondary substation (Figure 2). Tests were made against a national standard current transformer with amplitude accuracy better than 0.01 %. Each manufacturer's equipment was tested as a complete unit to ascertain the accuracy of the system, rather than an Individual component level.

Figure 2: Laboratory test setup at NPL

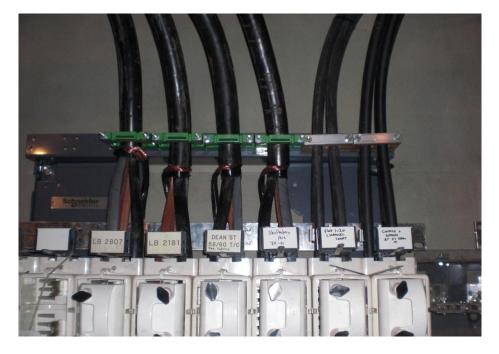
Figure 3: Top entry Schneider LV board showing separation of individual phase cores. (UKPN)

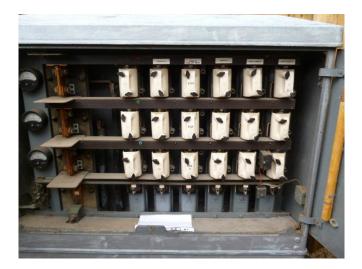
due to the makeup of the LV pillar. The example below (Figure 4) which is quite common, was deemed unsuitable for a range of reasons.

Figure 4: LV cast iron cabinet with compound filled tiered cable terminations.

Firstly, there were 6 LV feeder ways and while some manufacturers could accommodate this scale, it would have required modification. Modifications of the monitoring equipment were outside the scope of the trial, so sites with 6 or more LV feeder ways were discounted. Secondly, the cabinet was constructed out of cast iron and set on a solid brick plinth. This presented a problem in getting cables out of the cabinet to the control box. It is recognised that for a wider deployment this could be achieved by excavating around the pillar and bringing cables out of the base of the unit. However for the purposes of the trial it presented additional challenges that could be avoided by a different site choice. Where possible, sites were chosen where existing openings were available to allow sensor cables to be fed out of the cabinet without the need for creating additional holes.

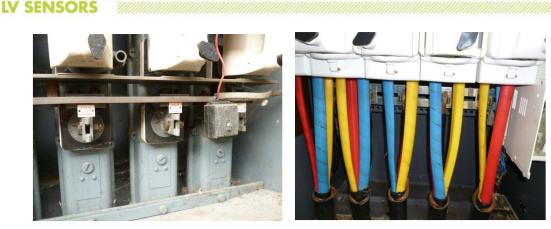
One further consideration was the cable terminations. In this case, as the cable enters the pillar it is terminated in a metal compound filled tiered box as shown in Figure 5. This meant that it was not possible to access the cable cores and therefore the LV sensors could not be installed around the conductors. If monitoring was required at this pillar it could be achieved using a flexible Rogowski coil, either around the transformer links to gain a whole substation view, or around the fuse carrier handles if a feeder by feeder view was required. However it is recognised that this presents further operational challenges as the each coil would need to be removed should the fuses require removal. The following photos show a tiered box with enclosed cores (Figure 5), and a more open termination with each core accessible (Figure 6).

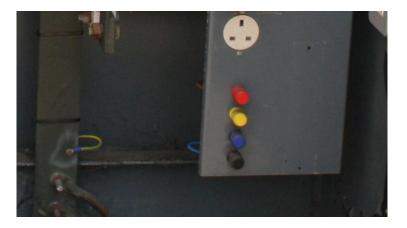
A number of pillars and LV cabinets have existing voltage test points which can be utilised to provide power and a voltage reference point for testing. These can be utilised to provide a three phase reference point and supply voltage for the cabinets. In some of the newer package substations, this will be a test block with live terminals. Older pillars (such as the one pictured in Figure 7 below) provide an alternative take off point that can be utilised. This required some modifications to the monitoring power leads. Where test points are present, it is recommended that a check is made during the pre-installation surveys to ensure that the terminals are live.

Figure 7: LV Cabinet with 3 phase test point

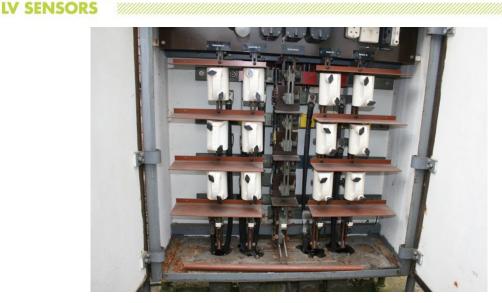
In a number of sites, the LV pillar / board will have exposed busbars that can be utilised to get a voltage reference. If terminals are not available, an approved nylon voltage clamp can be utilised with the appropriate fused leads. The following photograph (Figure 8) shows an open pillar where the voltage clamp may be appropriate. In this scenario it would be recommended to install the clamps to the side of the end set of fuses, so as not to interfere with any future operations on the boards.

Figure 8: LV Cabinet with open busbar design

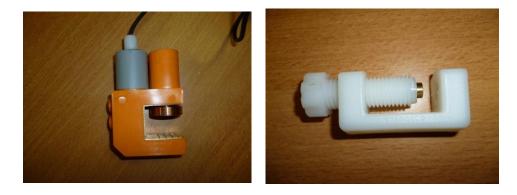
There are a number of voltage clamps which can be attached over the top of the busbars and tightened using an approved tool or integral screw. Prior to install a risk assessment should be made as to whether the clamps can be installed safely. Particular consideration should be made as to the location on insulated phase barriers and access to the bars. Full PPE should be worn for such activity in accordance with Distribution Safety Rules.

Figure 9 & 10: Voltage clamps manufactured by 1047 (left) and Martindale (right)

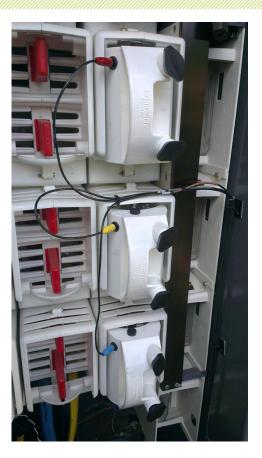
Should none of the above methods prove practicable, an alternative method is to replace a fuse carrier handle with a modified Schneider unit with a voltage terminal (Figure 11). These replacement fuse holders are ideal for enclosed boards although special consideration should be made as to their location. The disadvantage with such as solution is that trailing leads will be left down the front of the board and these will require unplugging before any operations can take place on that cable leg. Where possible, a spare leg should be utilised and the voltage take off point kept at the top to give a voltage for the bus bar. At present, these replacement carriers are only available for JS fuses with 3 5/8" spacing. Where a spare LV leg is not available, an alternative leg can be back fed, the fuse carriers replaced and the back feed removed.

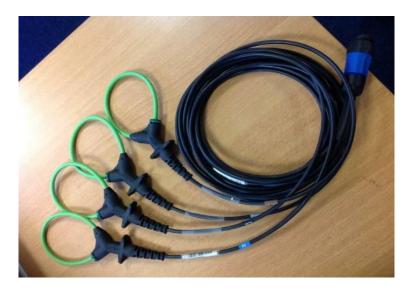
GMC i-Prosys in partnership with Nortech provided the sensors and metrology unit. The Rogowski coil sensors are able to measure three phases and neutral current and the design allows for easy installation around cable cores which have little spacing between them due to their thin profile. The bundling of the sensor cables into one connector also makes for good cable management and easy connection to the metrology unit provided.

Figure 1: Rogowski coils with single screw on connector from GMC i-Prosys.

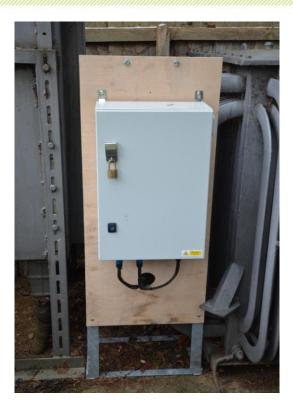
Figure 2: GMC i-Prosys metrology unit installed in outdoor substation. (WPD)

The metrology unit has a metal casing which is IP50 rated. For units with metal cases installed inside substations which are termed as Hot from an earthing perspective it is recommended to have separate neutral and earth or use an isolation transformer to supply power to the unit and use the HV earth to earth down the casing. The sensor connectors, which are of the screw type, are located at the bottom of the unit and these are easy to plug the sensors into. The metrology unit allowed for monitoring of up to 4 LV ways, although this was expandable to cater for up to 8 LV ways. There is also a temperature sensor provided with the metrology unit to measure the ambient air temperature of the substation. This is particularly useful when considering installation in indoor substations built in basements with poor ventilation where air temperature can be high leading to the degradation of the transformer if it is allowed to run hot for a prolonged period. The accuracy of this sensor was not tested during the laboratory or field trials. The SIM card slot is easily accessible to allow the SIM cards to be changed without powering down the unit.

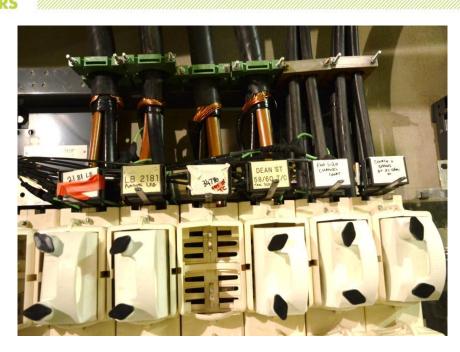
Figure 3: GMC i-Prosys Rogowski coils installed around tightly spaced cable cores.

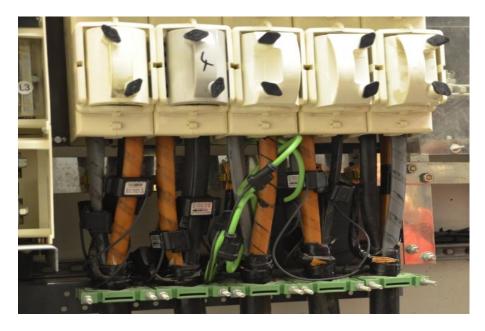
GridKey provided sensors and metrology unit along with voltage clamps and fused leads to use with the clamps. Two types of sensors based on Rogowski coil technology were supplied; one was a rigid Rogowski coil with a small aperture while the other was a flexible one with a wide aperture. The flexible sensor was used around phase cores which had very little spacing between them.

Figure 4: Rigid and flexible Rogowski coil sensors from GridKey. (UKPN)

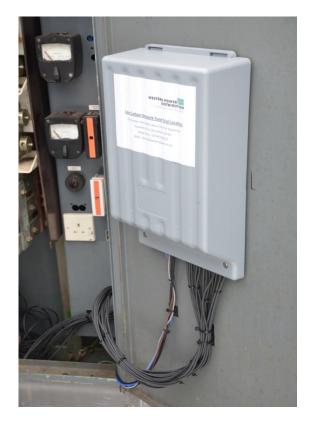
cannot ascertain whether the unit is functioning or not. Another downside is the sheer number of wires that are coming into the metrology unit since each sensor has to be plugged in individually. There is however a grooved cable rail at the bottom via which the cables come into the unit helping somewhat with cable management.

Figure 5: Sensor cables and voltage/power cables coming into the metrology unit (WPD).

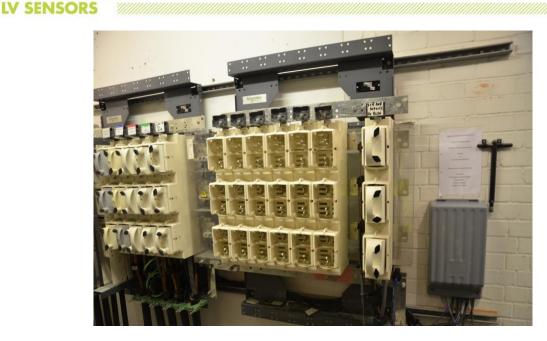
Figure 6: The GridKey MCU with the sensors and voltage leads connected. (UKPN)

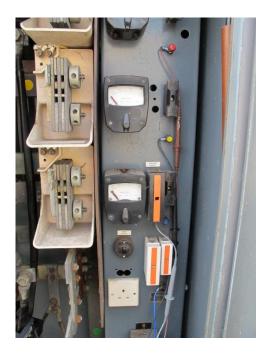
In order to obtain the three phase voltage and neutral reference and power for the metrology unit G-clamps were placed on the exposed part of the LV Board bus bars and fused banana plug leads were used.

Figure 8: Voltage take off points and fused leads. (WPD)

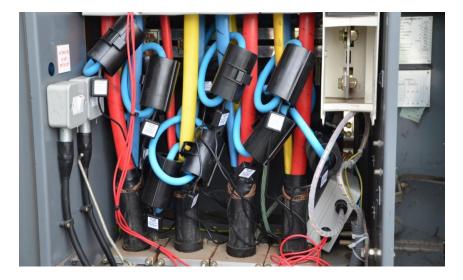
Current Grid provided two kinds of sensors based on Rogowski coil technology. There was a flexible blue sensor with a large aperture and a solid black sensor with a smaller aperture. Both sensors had their cable terminated with a USB interface. This made it easy for them to be connected to the metrology unit. The larger black plastic sensor proved difficult to install where cable cores were closely bunched, but it was recognised that the availability of a Rogowski coil was a welcome option for such circumstances. Each sensor was self-calibrating through an inline calibration unit manufactured into the sensor cabling.

Figure 9: Blue Rogowski coils by Current Grid in congested LV cabinet. (WPD)

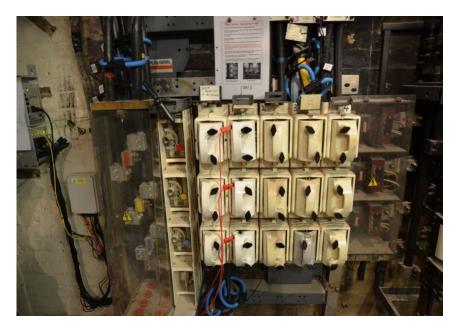
Figure 11: Current Grid monitoring solution installed in UKPN substation.

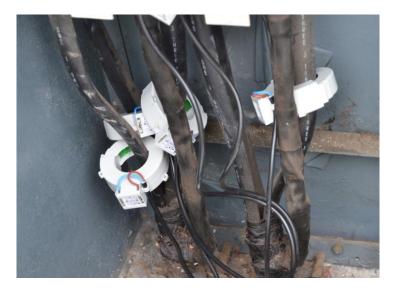
PowerSense provided split core CTs along with their DISCOS I/O module encasing the metrology and communication electronics in a plastic box. The split core CTs have a shorting link in them which prevent any dangerous voltages appearing between the terminals upon installation around an LV conductor. The link needed to be removed by the installer once the CT has been securely closed otherwise it will prevent the CT from functioning properly.

Figure 12: PowerSense split core CTs around LV phase cores (WPD).

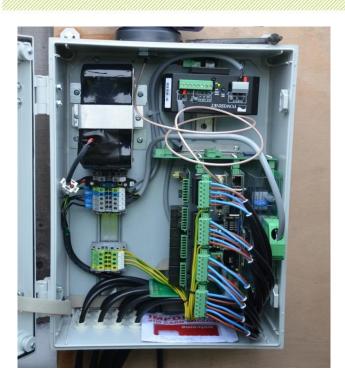
Figures 13: Internal components of the DISCOS I/O metrology unit from PowerSense. (WPD)

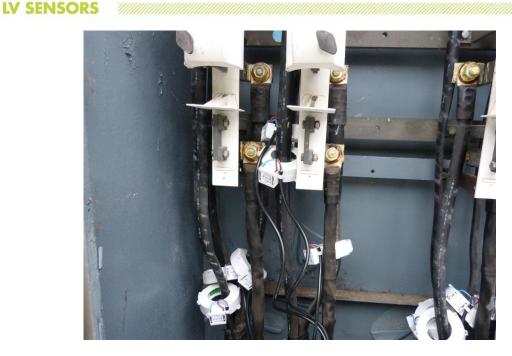
Figures 14: Example of CT installation high up cables due to spacing restrictions. (WPD)

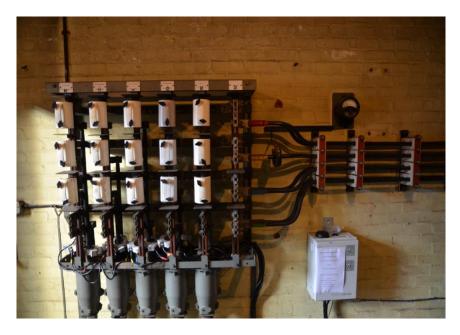
Figure 15: Installation of CTs and DISCOS metrology unit from PowerSense. (UKPN)

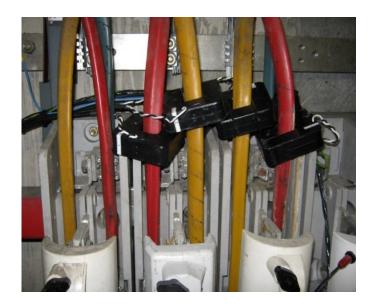
The installation of CTs was straight forward but only those LV ways could be installed on where the core conductors had sufficient spacing between them as can be seen from figure 19 below. One of the LV ways could not be installed on with these CTs because of this restriction. The CTs were bi-directional so it did not matter which way they were pointing when installed. They were labelled up to designate which CT went around which phase to assist the installer. Closure of the CTs was accompanied with a positive click confirming a correct installation.

Figure 19: Ambient CTs around core conductors on an open LV board. (UKPN)

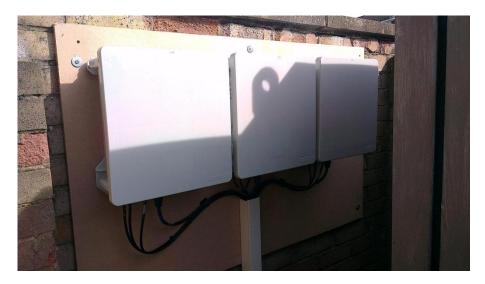
One metrology unit had to be used for monitoring one LV way. This meant that sufficient space needed to be available in the substation to mount the metrology units despite the compact nature of the units. This especially became a concern where multiple LV ways (up to 5) needed to be monitored. The metrology units were straight forward to mount using the brackets supplied. And connecting up the sensors and power/voltage reference leads was also very straight forward.

Figure 20: Ambient metrology units, one for each LV way. (WPD)

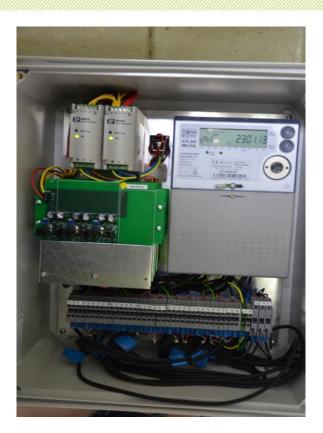
Figure 22: Data aggregation electronic boards and EDMI Atlas Mk10A meter inside the Haysys metrology unit.

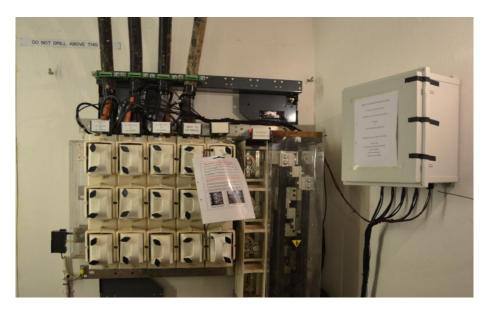
Figure 23: Rogowski coils wired into loom. (WPD)

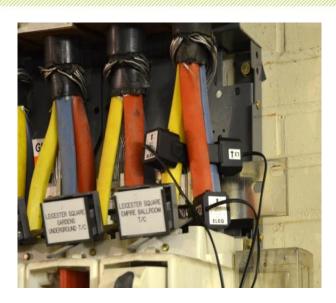
Figure 27: Locamation split core CTs around individual phase cores. (UKPN)

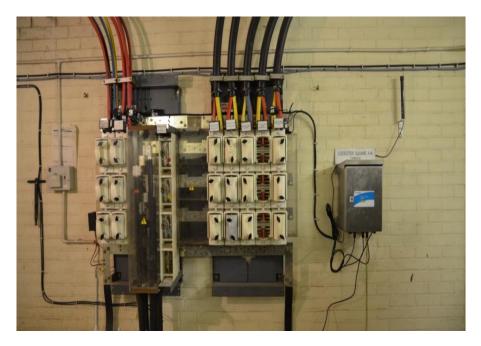
The metrology unit was easy to mount on the wall using the brackets provided. And due to its compact size would be ideal for substations with limited wall space. The CTs were also easy to connect to the unit due to the use of RJ45 LAN cable connectors and since there was one cable per LV ways this made cable management easier too.

Figure 28: Locamation monitoring unit installed in a substation. (UKPN)

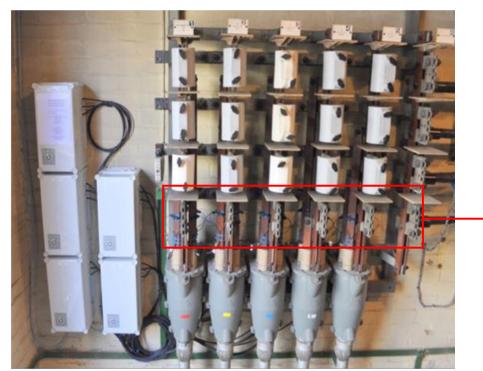
Current sensors will be of "split" type allowing them to be installed without disturbing the installed cables. These sensors may only be installed on the section of cable above the crutch of the cable termination and below the lowest fuse carrier (see Figure 1) where practicable. If this cannot be achieved further precautions must be taken and detailed within the method statement, and must not interfere with normal operational procedures within the substation. PPE in accordance with DSR 01 019 shall be required.

Area of work for installing current sensors
